Analyzing Landslide Risk Along the Sea to Sky Highway

GEOB 270: Introduction to Geographic Information Science
Final Project

Elias Braunstein, Jack Irwin, Rebecca Canam, Brett Pasula

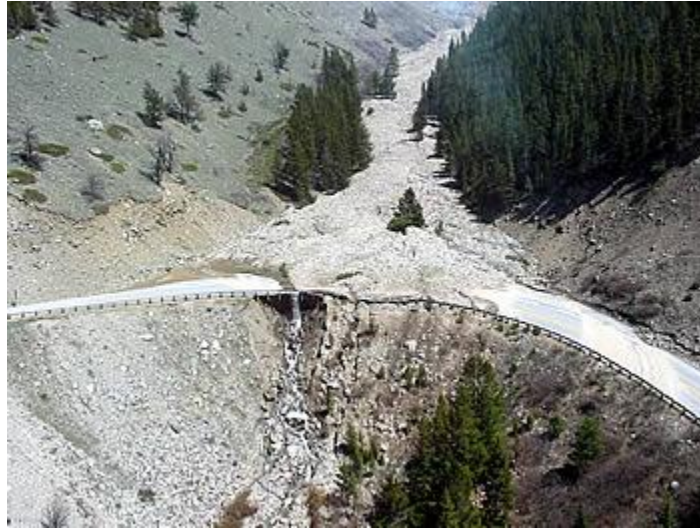
Figure 1: Channelized debris flow.

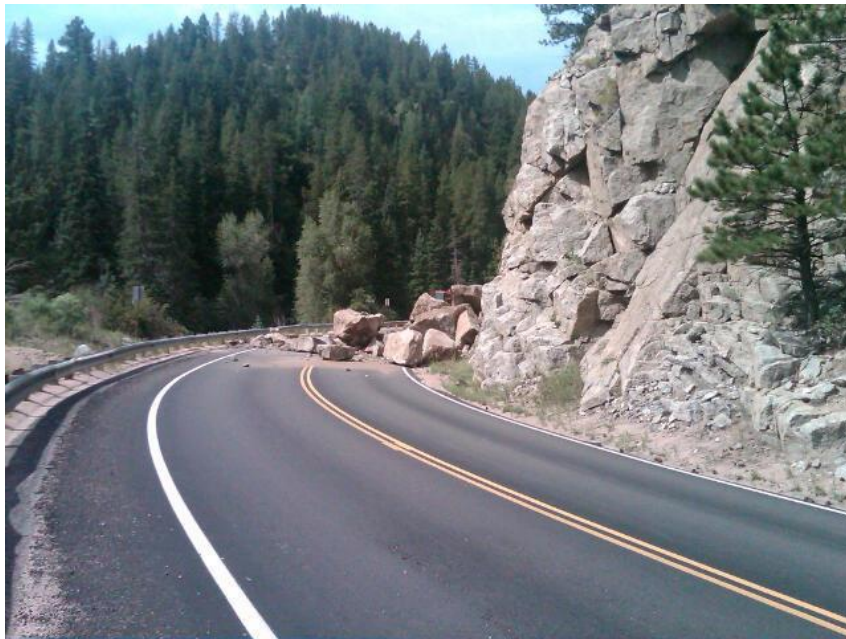
Figure 2: Rock fall from a steep roadcut.

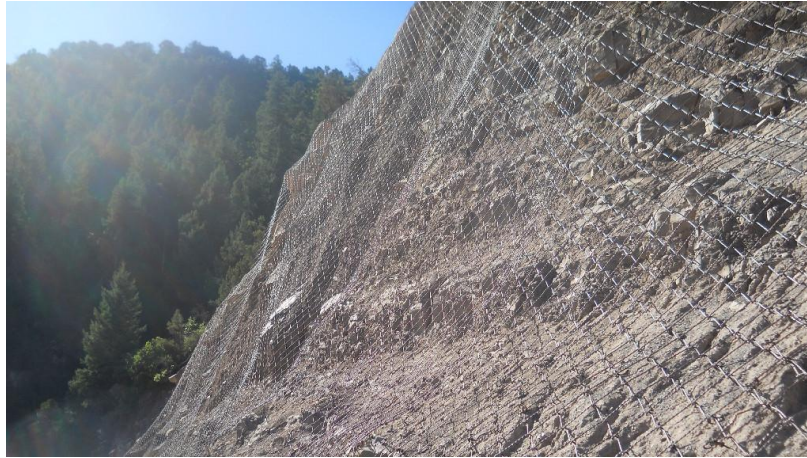
Figure 3: Rock fall netting used to capture large chunks of rock, and allowing them to pass safely to the base of the net.

The final maps produced delineate the areas along the sea to sky highway that, under our criteria, are at significant risk to future landslides. The only section of the highway that was found to be at risk through our analysis was a portion only slightly north of West Vancouver. These areas, depending on whether they are at the intersection of the highway and a roadcut, or the highway and a stream, should have protective measures emplaced. Areas deemed hazardous along roadcuts should have netting to catch falling rock and debris. Streams, which are most susceptible to debris flow events, should have catchment areas or underpasses which stop debris, or allow it move underneath the highway into the sound, respectively. Photos of these structures are highlighted in the photos below (Figures 3 and 4).

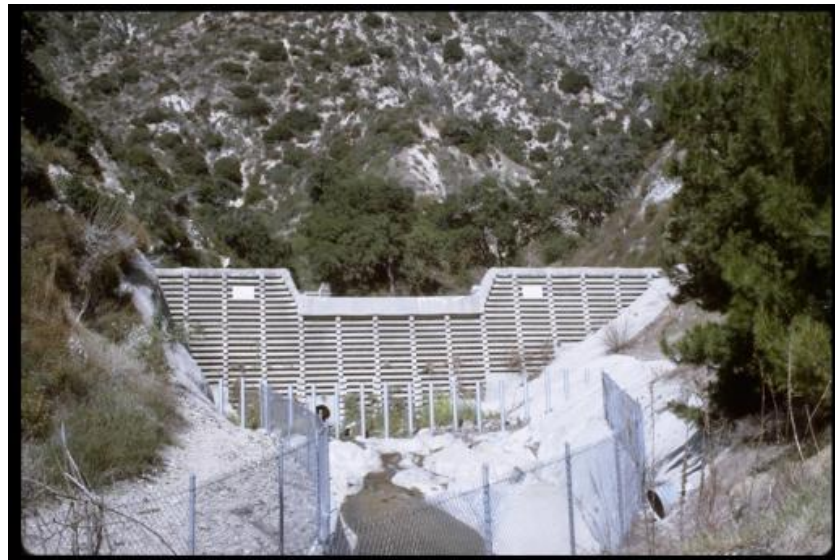
Figure 4: Debris flow catchment structure which stops large solids from passing, but allows water and fine sediment to travel downstream.
