Stability of the UBC Point Grey Cliffs and the Effects of Vegetation on Slope Stability

2016 December 6

Quaternary and Applied Geomorphology 308

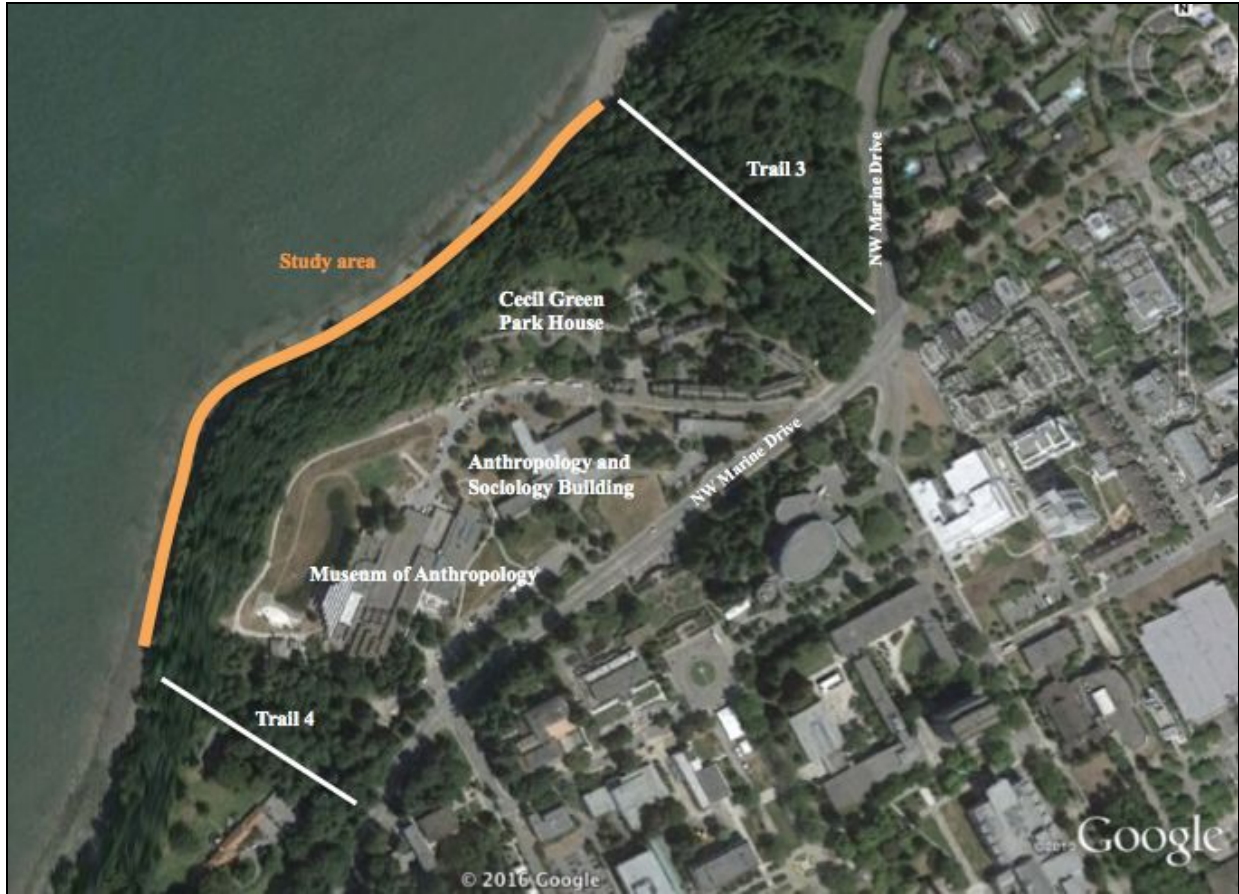
Figure 1. Study area. Screenshot taken from Google Earth

A combination of field data and research was used to determine the stability of the Point Grey Cliffs. Data regarding the slope angle, depth, vertical scale, and sedimentary makeup of the cliffs were collected from the study area (see Figure 1) using a trowel, tape measure, brunton, and a Munsell Chart. Various UBC Community Planning documents and scientific journals were also reviewed to determine key factors that affect the stability of the cliffs.

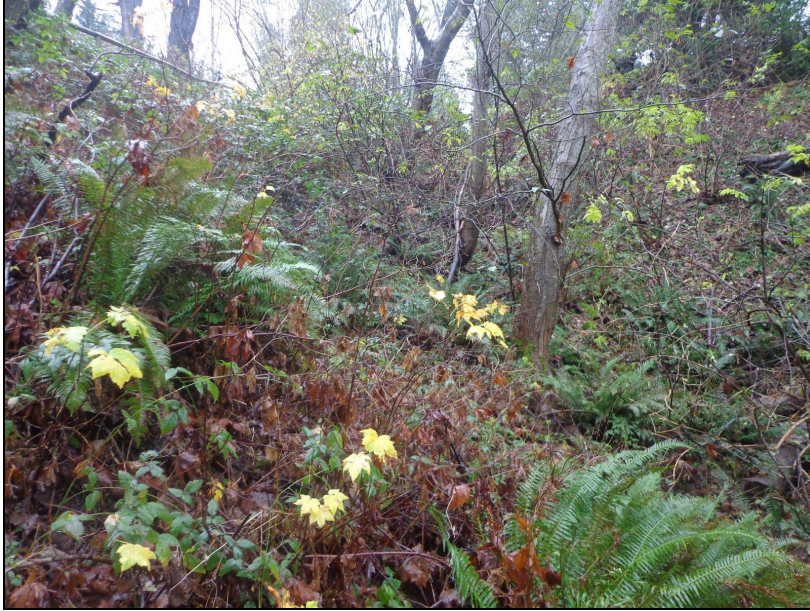
Figure 2. Example of Terrain Stability Class 2 (Liu, B. *Terrain stability class 2*. 2 December 2016).

Terrain Stability Class	Interpretation
I	No significant stability problems exist. - Low or no slope angle (<27.5°)
II (see Figure 2)	Low likelihood of slope failure. - Moderate slope angle (<27.5°) - Mature forest - Dense undergrowth
III (see Figure 3)	Minor stability problems with moderate likelihood of slope failure. - Moderate to steep slope angle (27.5° - 60°) - Less dense forest or populated by young trees - Less dense undergrowth - Presence of dead vegetation
IV (see Figure 4)	Larger stability problems with a moderate likelihood of slope failure. - Steep slope angle (>60°) - Sparse forest of young trees - Sparse undergrowth - Presence of dead vegetation - Exposed sand faces
V	High likelihood of slope failure. - Steep slope angle (>60°) - Little to no trees - Little to no undergrowth - Presence of dead vegetation - Exposed sand faces

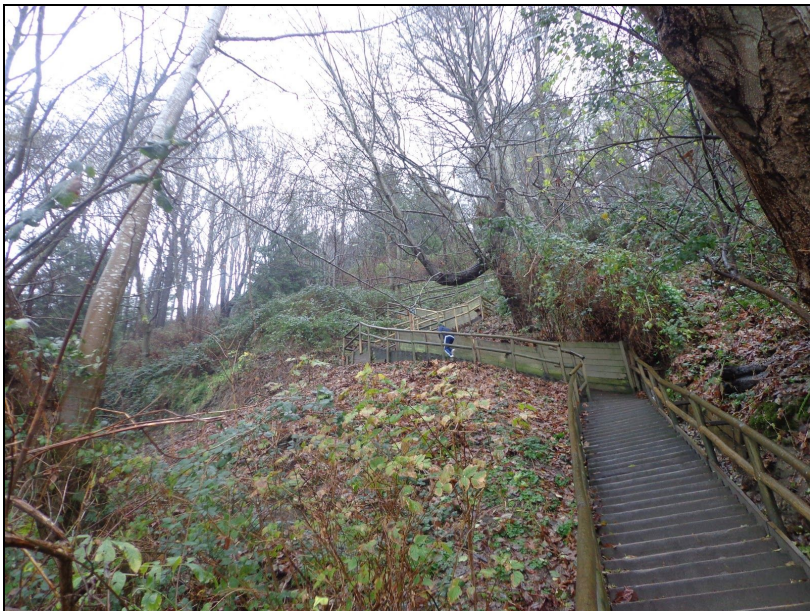
Figure 3. Example of Terrain Stability Class 3 (Liu, B. *Terrain stability class 3*. 2 December 2016).

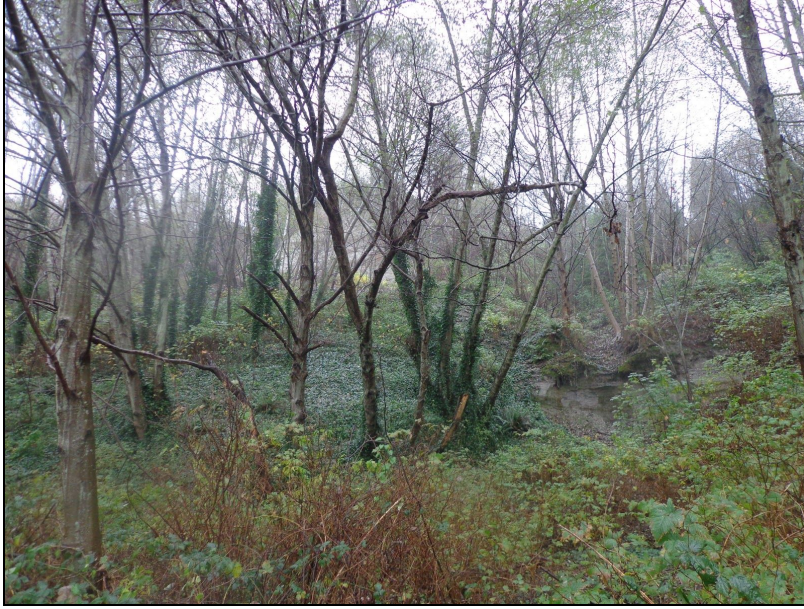
Figure 4. Example of Terrain Stability Class 4 (Liu, B. *Terrain stability class 4*. 2 December 2016).
