Catena 46 (2002) 285–307

# Frequency and spatial distribution of landslides in a mountainous drainage basin: Western Foothills, Taiwan

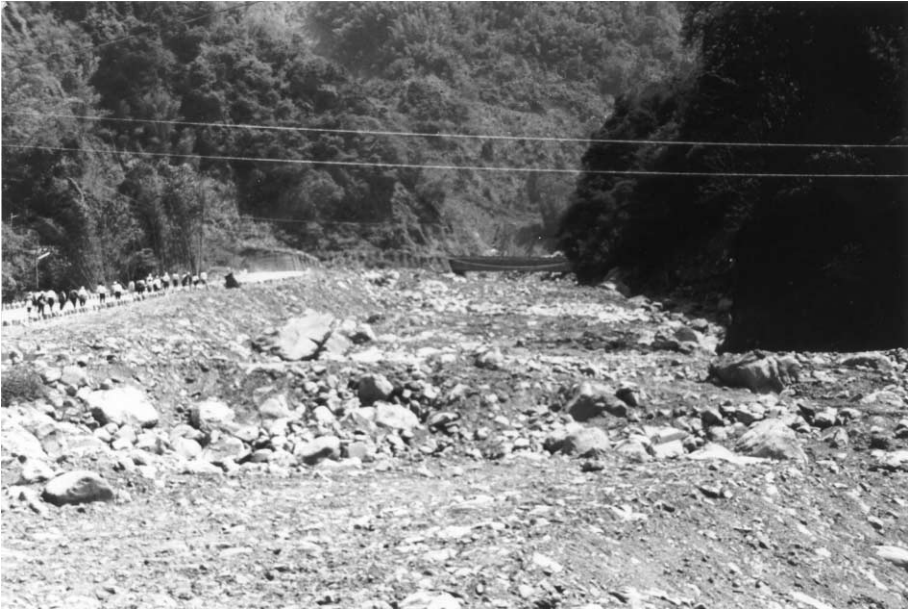
Fig. 10. Debris torrent, tributary to the Chu-shui River (photo by J.-C. Chang: March 14, 1997).

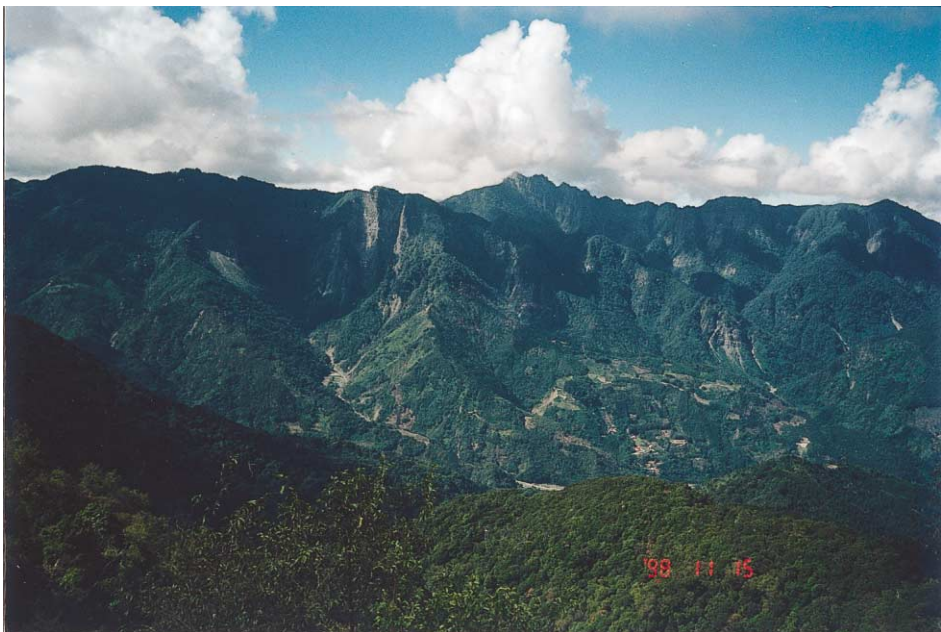
Fig. 11. Landslides in the headwaters of Sung-shan River basin (photo by J.-C. Chang: November 15, 1997).
