How the earthquakes and landslides affect Quito, my place.

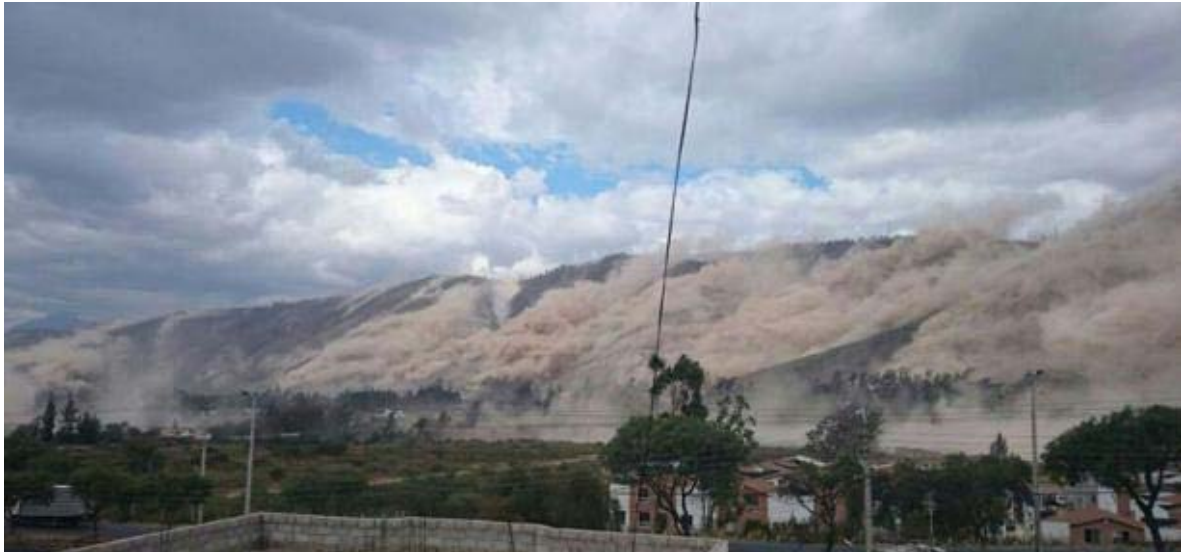
One of the most recent an important earthquakes (5.1 Ritcher Scale) happened in August 2014, the focus was about 7.7 km deep. This earthquake caused more than 50 aftershocks, few deaths but multiple injured people because of the landslides, liquefaction and collapsed houses.

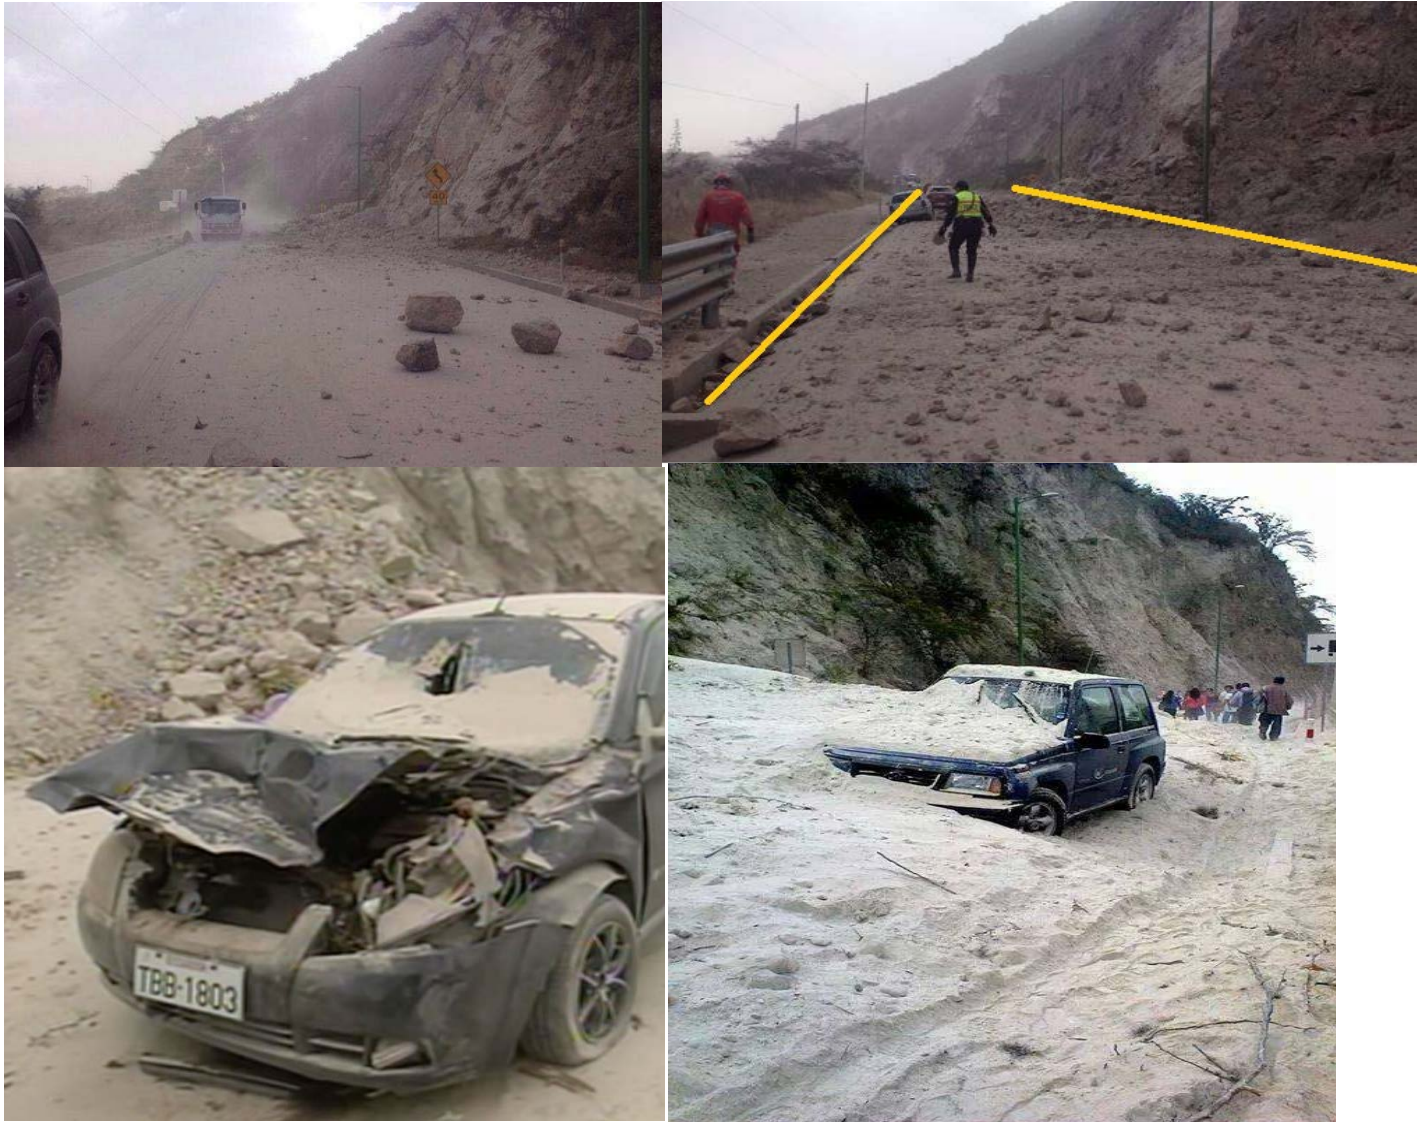
However, as the topography of the city is very irregular with many steep slopes and ravines, there are some places in which the ground is more stable and consolidated than other places. Ravines and slopes are most common at the sides of the city. Certainly in the slopes and ravines the material is slippery and unstable. As a result of an earthquake this zones are most likely to have landslides. After the earthquake in 2014 there were landslides which were mostly soil, debris and rock fall, however in some parts there was also rotational slides; this blocked many highways and injured people in their cars. (see pictures)

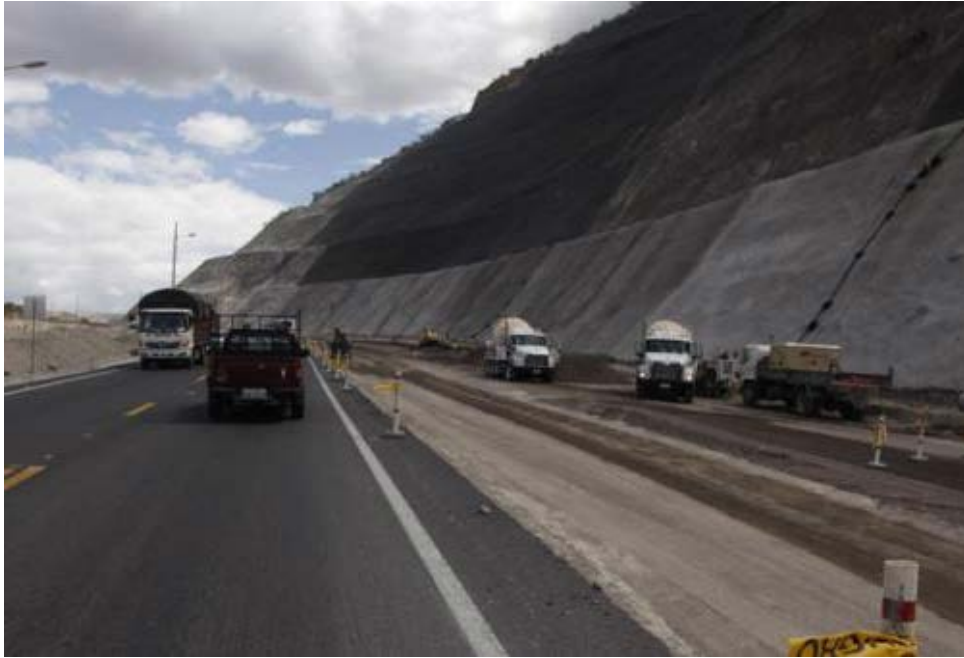
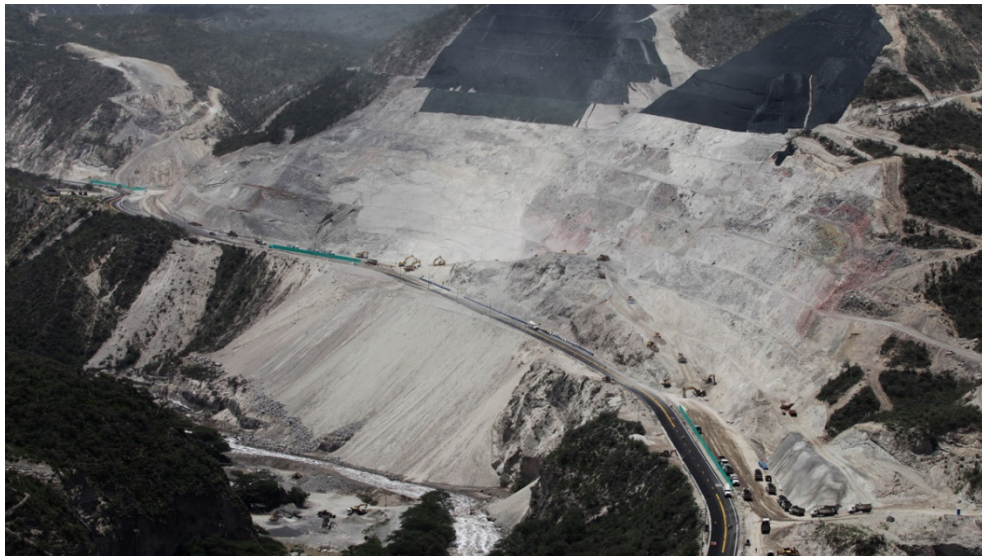
After this incidents the mountains were cut and shaped in order to make it less dangerous in future events. (Below there are 2 pictures of the same highway, the mountains have been cut in terraces).

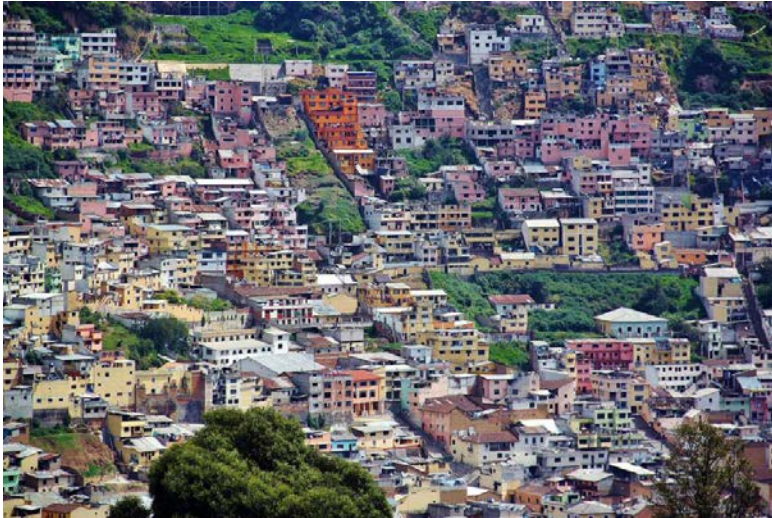
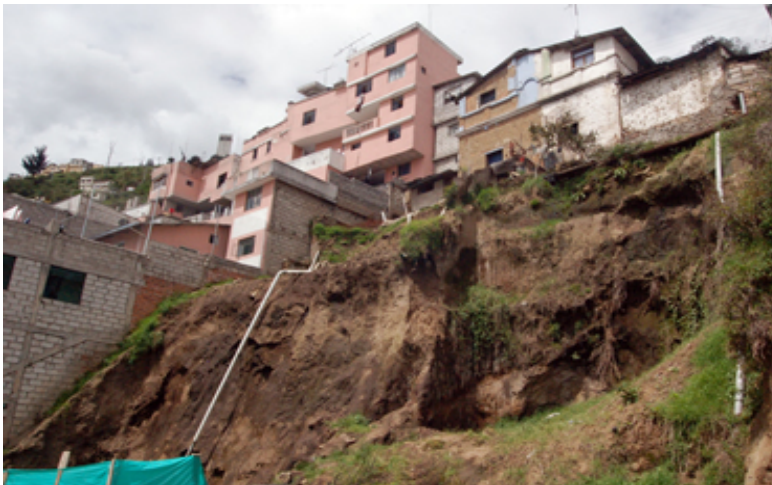
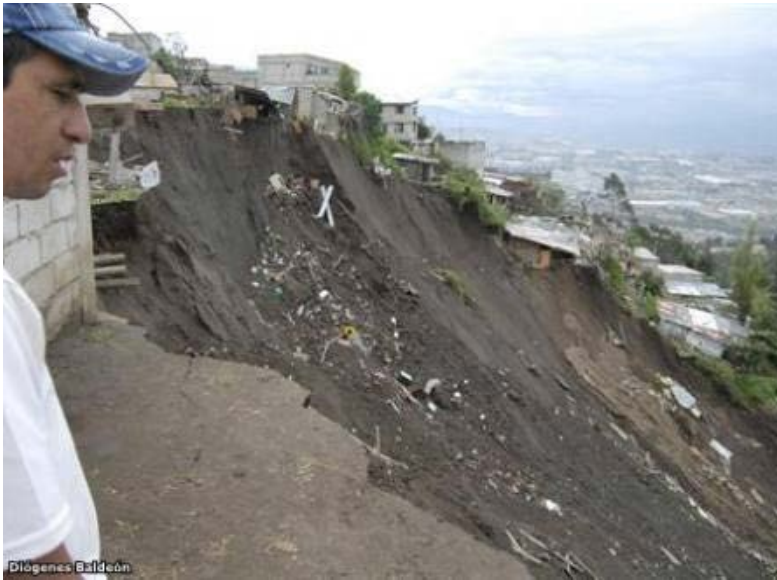
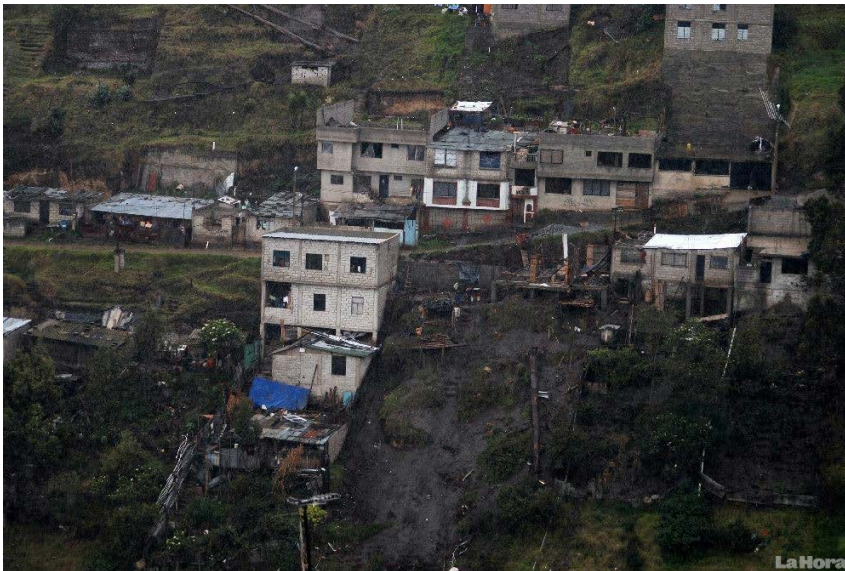
On the other hand, Quito's rapid urban growth caused the expansion of the city along the valley floor. However, the city was not prepared to receive such unprecedented population increase which is why people started to build illegally wherever they could without municipal permits. This means filling ravines with soil

and waste to make the place flatter and build houses. (Guéguen, Chatelain, Guillier, & Yepes, 2000) This is very dangerous because the soil is not compacted enough which makes it unstable and most likely to liquefaction, landslides and collapse. Not only earthquakes but also the heavy rain falls, put in danger all this houses which obviously are not anti-seismic structures.
