# Analyzing Landslide Risk Along the Sea to Sky Highway

*GEOB 270: Introduction to Geographic Information Science*  
Final Project

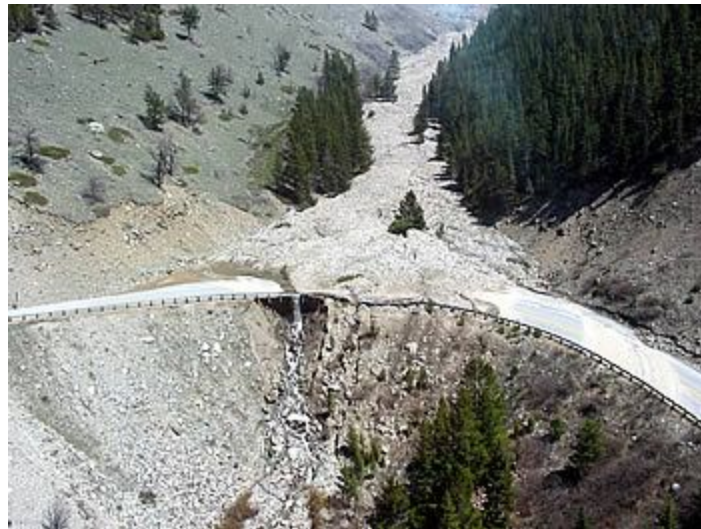
*Figure 1: Channelized debris flow.*

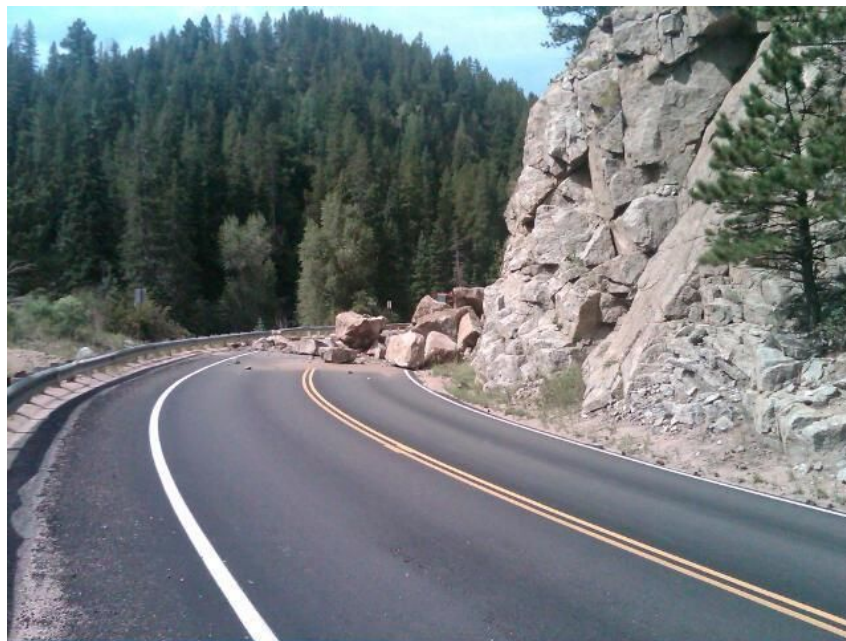
*Figure 2: Rock fall from a steep roadcut.*

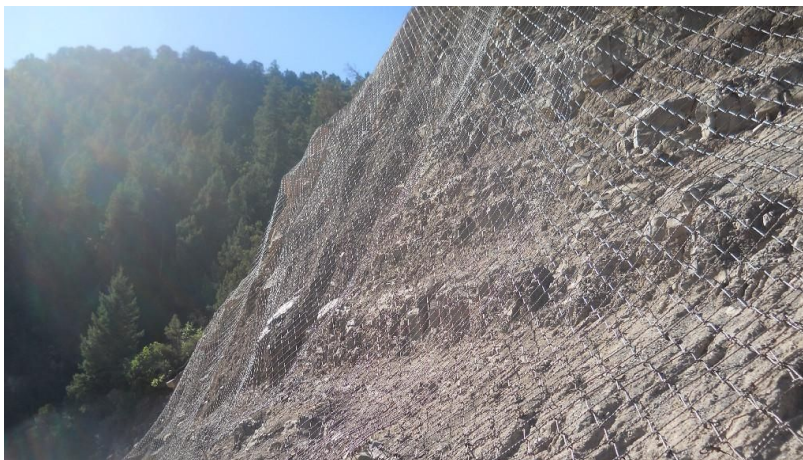
*Figure 3: Rock fall netting used to capture large chunks of rock, and allowing them to pass safely to the base of the net.*

The final maps produced delineate the areas along the sea to sky highway that, under our criteria, are at significant risk to future landslides. The only section of the highway that was found to be at risk through our analysis was a portion only slightly north of West Vancouver. These areas, depending on whether they are at the intersection of the highway and a roadcut, or the highway and a stream, should have protective measures emplaced. Areas deemed hazardous along roadcuts should have netting to catch falling rock and debris. Streams, which are most susceptible to debris flow events, should have catchment areas or underpasses which stop debris, or allow it move underneath the highway into the sound, respectively. Photos of these structures are highlighted in the photos below (Figures a and b).

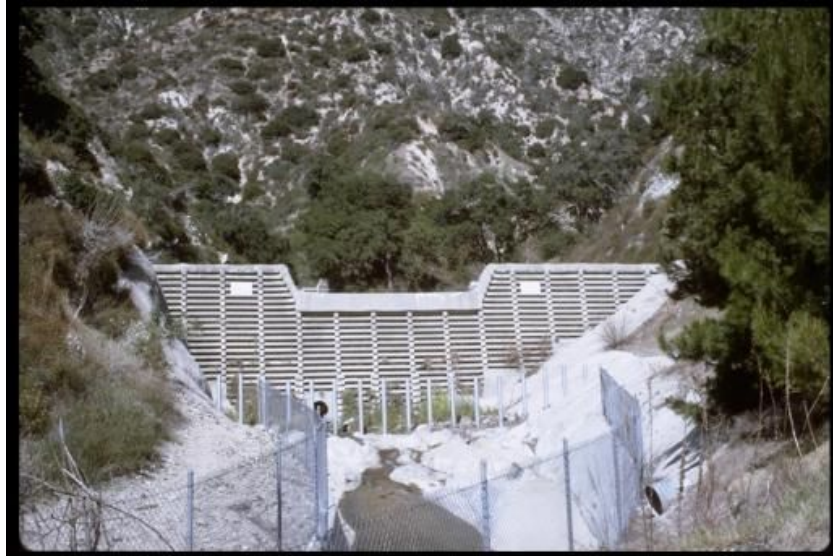
*Figure 4: Debris flow catchment structure which stops large solids from passing, but allows water and fine sediment to travel downstream.*
